Subject: Department of Natural Resources Washington Geological Survey,
School Seismic Safety Assessment Project, Contract No. AE 410 -
Seismic Evaluation for **Sunnyside School District**

1. Outlook Elementary School, Outlook Elementary School Main Building

1.1 Building Description

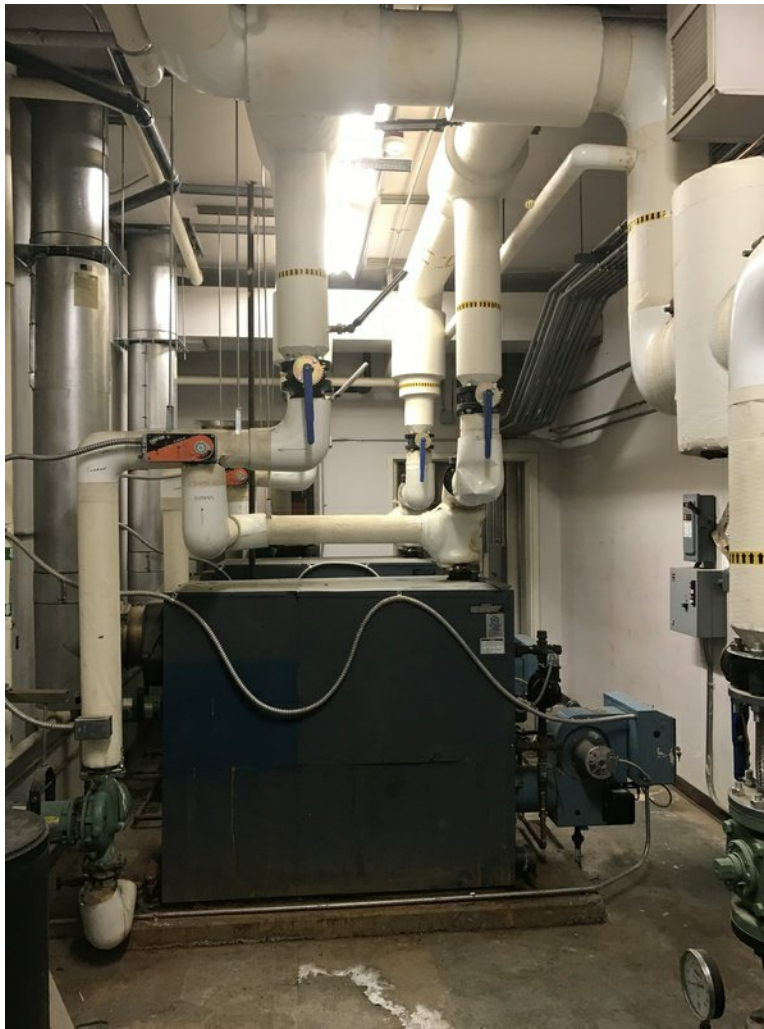
Figure 1-5. Mechanical Room

M-3 Weakened Planes. HR-not required; LS-LMH; PR-LMH.	Further investigation required to verify anchorage of masonry veneer at weakened planes.
ME-2 In-Line Equipment. HR-not required; LS-H; PR-H.	This evaluation could not be visually verified. Further investigation is required to review vertical support and lateral bracing of equipment.
